# HOME REPORT

62C CASTLE STREET  
BROUGHTY FERRY  
DUNDEE  
DD5 2EJ

# Energy Performance Certificate (EPC)

# Single Survey

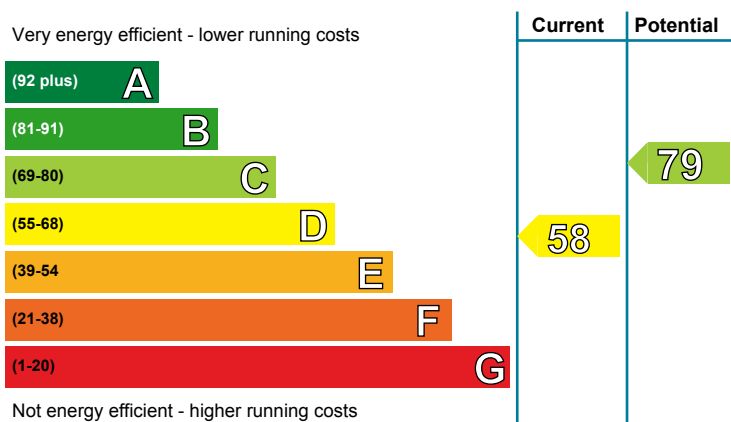
## Energy Efficiency Rating

This graph shows the current efficiency of your home, taking into account both energy efficiency and fuel costs. The higher this rating, the lower your fuel bills are likely to be.

Your current rating is **band D (58)**. The average rating for EPCs in Scotland is **band D (61)**.

The potential rating shows the effect of undertaking all of the improvement measures listed within your recommendations report.

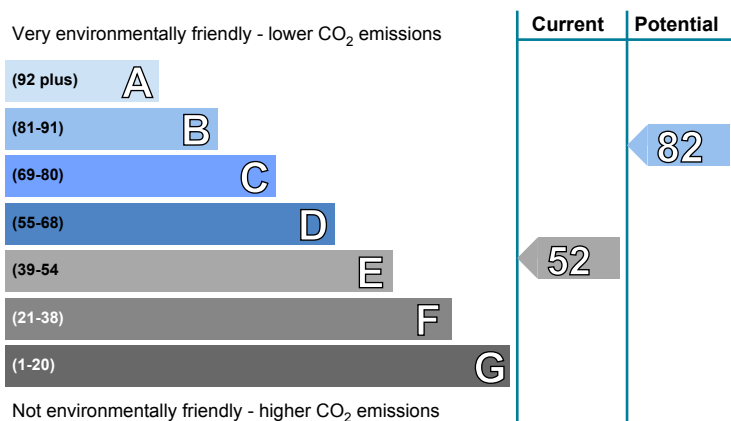
## Environmental Impact (CO<sub>2</sub>) Rating

This graph shows the effect of your home on the environment in terms of carbon dioxide (CO<sub>2</sub>) emissions. The higher the rating, the less impact it has on the environment.

Your current rating is **band E (52)**. The average rating for EPCs in Scotland is **band D (59)**.

The potential rating shows the effect of undertaking all of the improvement measures listed within your recommendations report.
