# HOME REPORT

32D KENMORE TERRACE  
DUNDEE  
DD3 6EJ

# Energy Performance Certificate (EPC)

# Single Survey

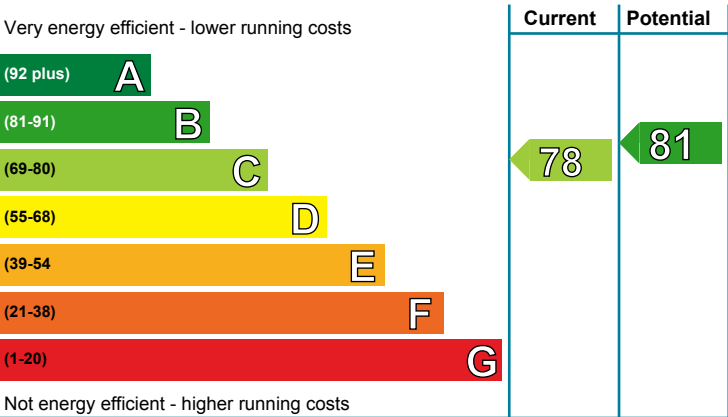
## Energy Efficiency Rating

This graph shows the current efficiency of your home, taking into account both energy efficiency and fuel costs. The higher this rating, the lower your fuel bills are likely to be.

Your current rating is **band C (78)**. The average rating for EPCs in Scotland is **band D (61)**.

The potential rating shows the effect of undertaking all of the improvement measures listed within your recommendations report.

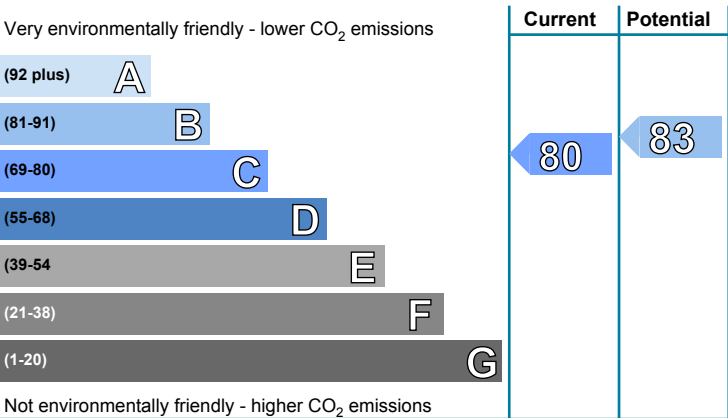
## Environmental Impact (CO<sub>2</sub>) Rating

This graph shows the effect of your home on the environment in terms of carbon dioxide (CO<sub>2</sub>) emissions. The higher the rating, the less impact it has on the environment.

Your current rating is **band C (80)**. The average rating for EPCs in Scotland is **band D (59)**.

The potential rating shows the effect of undertaking all of the improvement measures listed within your recommendations report.
