# HOME REPORT

31 HOMETAY HOUSE  
2 HIGH STREET  
MONIFIETH  
DUNDEE  
DD5 4BN

# ENERGY PERFORMANCE CERTIFICATE

# Single Survey

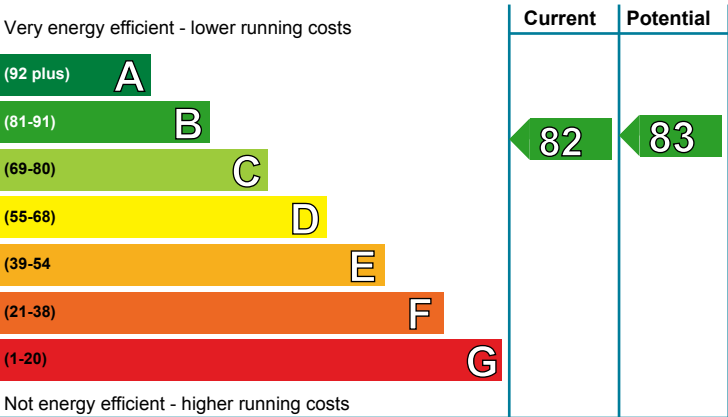
### Energy Efficiency Rating

This graph shows the current efficiency of your home, taking into account both energy efficiency and fuel costs. The higher this rating, the lower your fuel bills are likely to be.

Your current rating is **band B (82)**. The average rating for EPCs in Scotland is **band D (61)**.

The potential rating shows the effect of undertaking all of the improvement measures listed within your recommendations report.

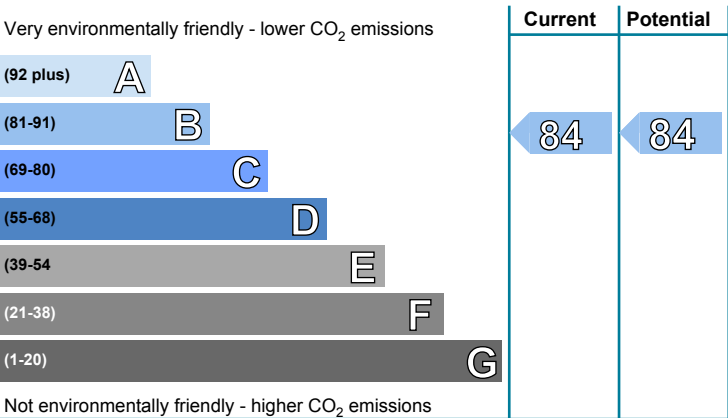
### Environmental Impact (CO<sub>2</sub>) Rating

This graph shows the effect of your home on the environment in terms of carbon dioxide (CO<sub>2</sub>) emissions. The higher the rating, the less impact it has on the environment.

Your current rating is **band B (84)**. The average rating for EPCs in Scotland is **band D (59)**.

The potential rating shows the effect of undertaking all of the improvement measures listed within your recommendations report.
